BEAR Engineering (650) 722-0830 www.beareng.com bearfoundationservice@gmail.com

Inspection Date: 5/5/22

Address: 555 Standard St.

## **Observed Condition - Floor elevation results & signs of foundation movement**

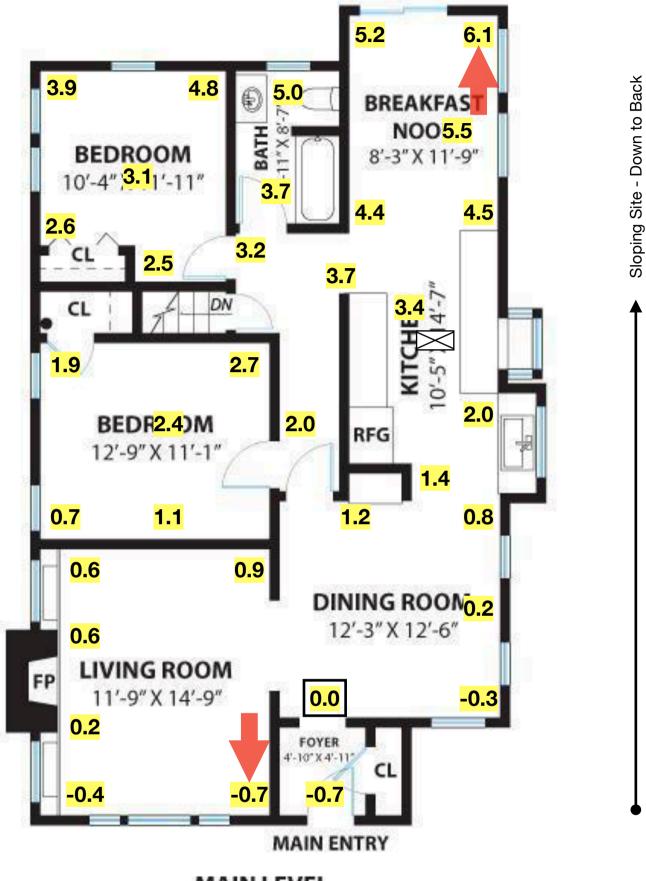
- The interior floors were spot checked for levelness using a Ziplevel, a high precision digital altimeter.
- The maximum elevation change was observed to be 6.8" between the red arrows shown.

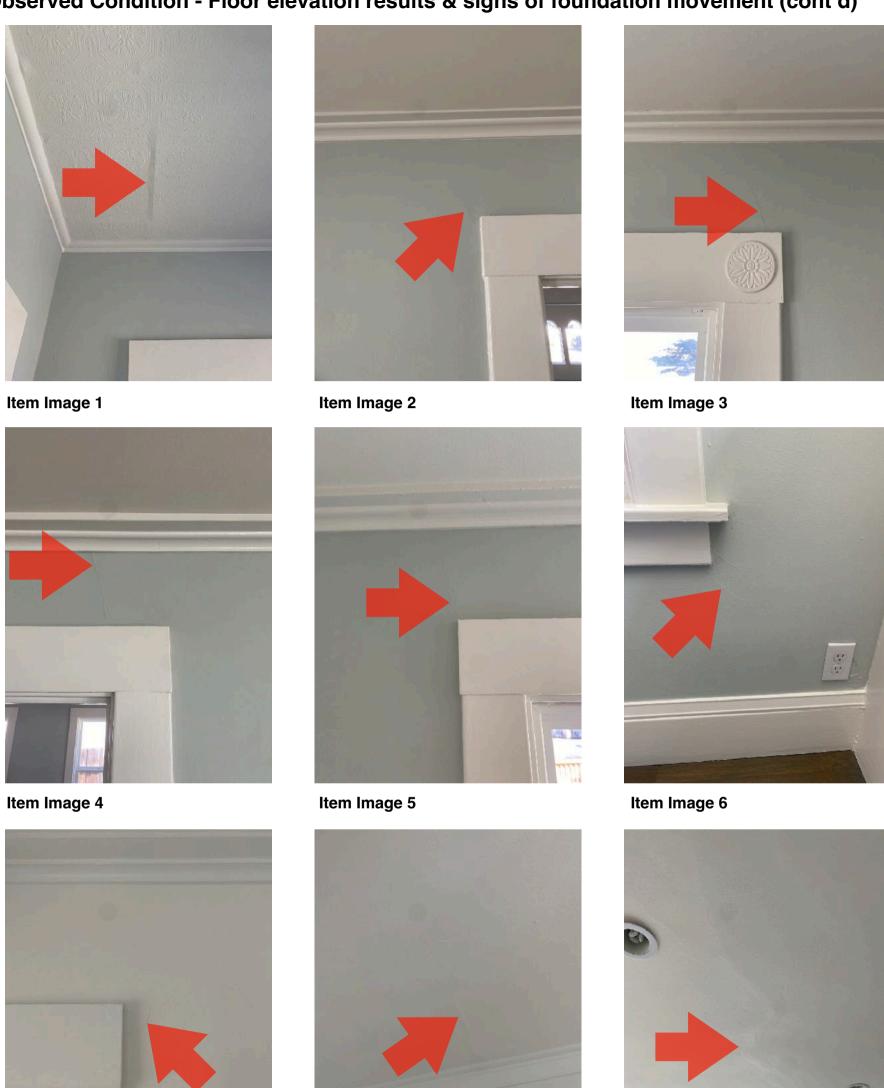
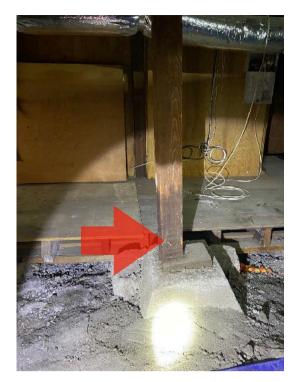
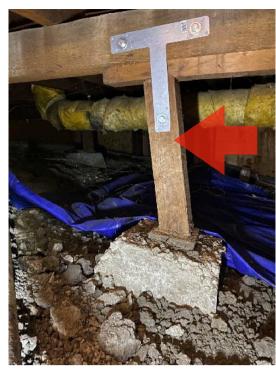
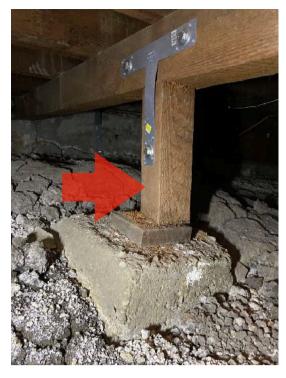
- There were a few interior indications that could be consistent with minor foundation movement as shown in the pictures above, but these were relatively minor. (note: we do not necessarily take a picture of every crack, rather a representative number).

- The exact cause of the movement is unknown. Only a soils report with deep borings & lab analysis can provide the data necessary to fully analyze (this process is naturally quite expensive) see Attachment 9 for a list of potentially contributing factors.

- The only way to fully prevent future movement is underpinning the foundation. This procedure taps into more stable soil or rock, deep in the earth, through push piles, helical anchors, drilled piers (or similar) and brackets which anchor the foundation to the piles. This effectively supports the home on more stable ground (see illustrations on Attachment 5 and view the Foundation Education link on our website with links to videos on this process).

- The final decision will depend on the owner and be a subject determination. The minimum recommendation is:
  - Ensure surface water is controlled around the property as well as possible as water combined with expansive soils can contribute to foundation settlement.

- Patch existing cracks and monitor for future ones.
  - Use this survey as a baseline for future readings to see if there is active movement occurring.

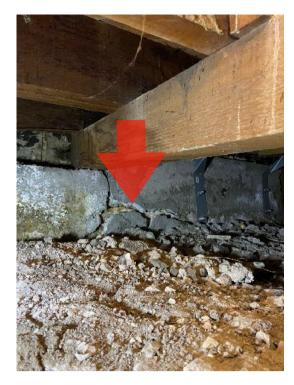
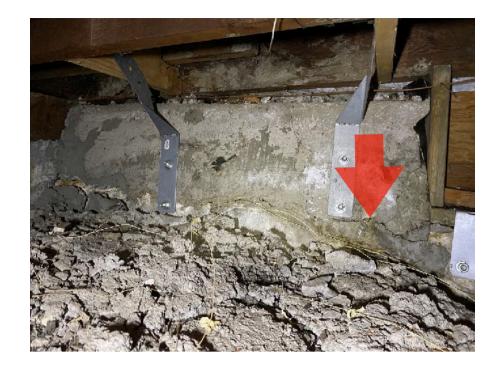
- **Observation Details**: These cracks generally occur from a combination of shallow foundation embedment depth and expansive soils which will swell when wet and contract when dry (see Attachment 2), foundation settlement, or past seismic activity.
- Severity: There was 1 multi-directional crack over 1/2" in aperture.
- Options:
  - Option 1: Underpin the area and stitch the crack together with rebar and concrete. Budgetary cost range of \$3K +/- 30% per location.
  - Option 2: Replace this section of the foundation. The length of the crack is approximately 5ft, and budgetary cost range of \$1K/linear ft +/- 30%.
- Recommendation: We'd recommend Option 2, total budgetary cost range of \$5K +/- 30%.

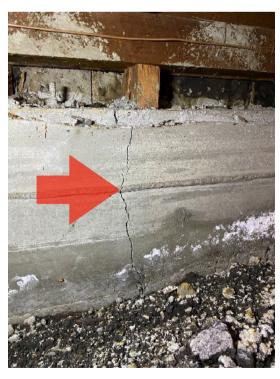
Item Image 1

- Observation Details: These cracks generally occur from a combination of shallow foundation embedment depth and expansive soils which will swell when wet and contract when dry (see Attachment 2), foundation settlement, or past seismic activity.
- Severity: There was approximately 1 cracks 1/4" or less.
- Options:
  - Option 1: Mark & monitor (negligible cost homeowner or handyman repair).
  - Option 2: Cover the crack surface with epoxy (\$200 +/- 30% per crack homeowner or handyman repair).
  - Option 3: Inject structural epoxy under pressure into the crack (\$500 +/-30% range per crack qualified contractor repair).
- **Recommendation**: Since the cracks are so small, at this point we'd recommend Options 1 or 2 (a minimal cost item).

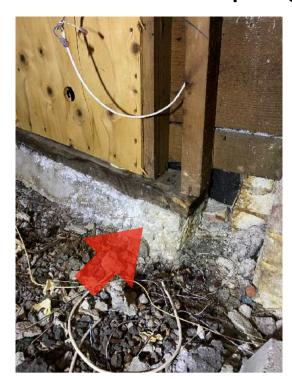
Item Image 1

- Observation Details: There are various forms of spalling but this one is the result of
  the chemical breakdown of the cement within the concrete mix (rock, sand, cement).
  Typical causes of spalling concrete include but are not limited to the following:
  excessive moisture and/or poor site drainage conditions, poor quality cement used in
  the concrete mix, the ratio of cement with relationship to the amount of sand and
  rock in the concrete mix is too low & the sand used in the concrete mix has excess
  salt-mineral residue.

- Severity: A probe was used to strike various areas to investigate the extent. It appears the damage is primarily on the surface at the front, left side of the house with solid concrete remaining beyond. Had the foundation crumbled in areas when probing it would be of greater concern, but that was not the case. (Note: destructive testing is not part of this inspection; more advanced methods such as core samples or extensive rebound hammer testing would be required for a full analysis).

- **Options**: There is no good repair for situations like this (short of foundation replacement). Rather, it is something to be aware of, monitor, and improve the water control to the extent possible and as mentioned in other areas of the report.

- End Conclusion: Most owners would simply be aware of the condition and monitor periodically (check on in 3-5 years).

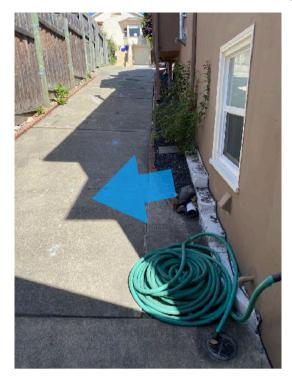
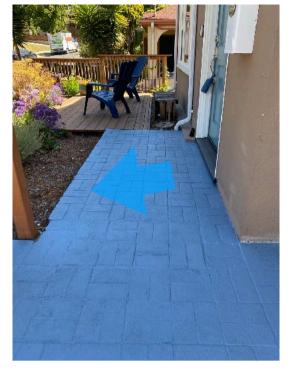
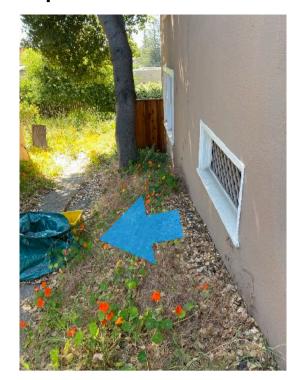
Item Image 1 Item Image 2 Item Image 3

- **Observation Details**: It is recommended to ensure adequate slope away from the house in all areas such that surface water will flow away from the foundation. Arrows in the images above show the direction that water should be flowing. This was largely achieved on the left side of the house (Image 3), but improvements could be made to the front, right, and rear of the house.

- Options (see Attachment 3 for illustrations):
  - Option 1: Re-grade the soil around the structure to slope away from the foundation, this is generally a relatively minimal cost and can be either DIY or accomplished by competent landscaping companies.

- Option 2: Install hardscape (i.e. impervious surface such as concrete or tightly spaced pavers) to slope away from the foundation; budgetary cost range per side of an average sized house would be \$5K +/- 30%. In areas where hardscape already exists, apply mud jacking (also known as slab jacking or poly-level) to elevate one side of the slab and achieve positive slope away from the house; budgetary cost range would be \$3K +/- 30% per slab area and this would only need to be applied where the hardscape currently slopes toward the house.

- Option 3: Install subsurface drainage (French Drains or similar) to minimize the water near the foundation (full french drains around an average sized house might be in the \$40K +/- 30% range).

- In this case, a combination of approaches is recommended.
  - Mud jacking would likely be feasible in the front of the house where existing hardscape is present.
  - Along the right of the house, new hardscape (Option 2) up to the foundation, or preferably a French drain (Option 3) should be installed, which could be incorporated into revised subsurface drainage along the right side and past the rear of the house to discharge to the rear of the back yard.
  - Mud jacking could be implemented in the rear of the house, or hardscape replaced if new subsurface drainage systems are to be installed.
- The total budgetary cost will depend on the combination of approaches taken.

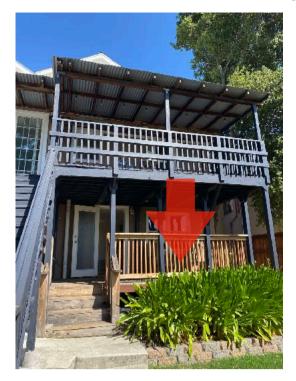
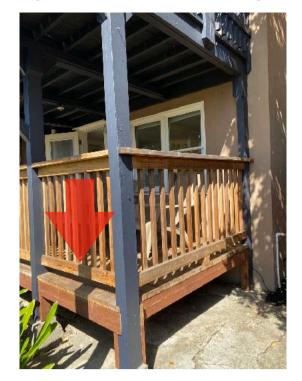
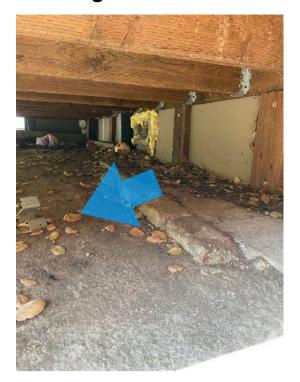
Item Image 1 Item Image 2 Item Image 3

- **Observation Details**: It is recommended to ensure adequate slope away from the house in all areas. It is possible that some water that flows along the right side of the house diverts to below the rear deck and pools water.
- **Recommendation**: The current roof above the deck prevents stormwater from directly reaching below the deck, but drainage to the area below the deck should be observed during future rain events to determine if water flows away from the foundation as desired and shown by the blue arrow in Image 3. If water pools in this area, hardscape with adequate slope or subsurface drainage systems as discussed previously should be considered.

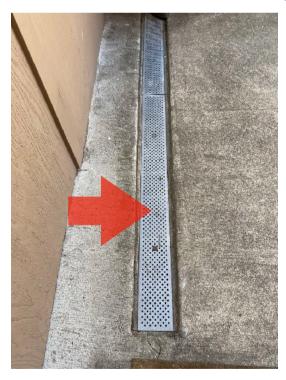
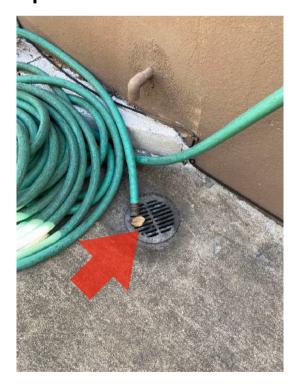
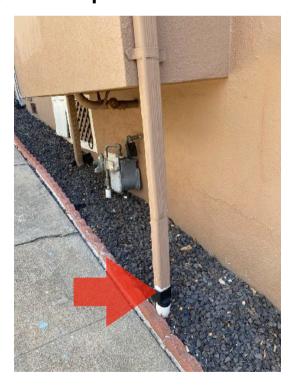
- Observation Details: It is recommended to ensure adequate drainage away from the house in all areas.
- Severity: Locations noted in the pictures above and similar locations (note: we do not take pictures of every location).
- **Recommendation**: Periodically have these inspected and cleaned if necessary to ensure adequate water transport away from the foundation (relatively minor cost to inspect & from there it depends on the conditions found).

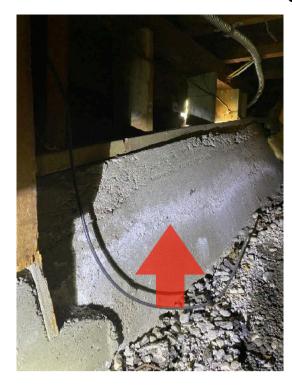
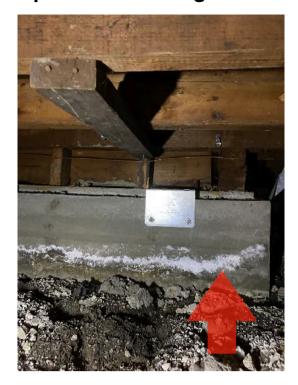
- **Observation Details**: Efflorescence is an indication of excessive moisture that appears when water that contains soluble salts evaporate from the surface of the foundation, resulting in a crystalline salt deposit. The deposits are usually white but they can also be green, brown, or gray depending on the mineral composition.
- **Severity**: Not a severe condition in and of itself but can be an indication that improved drainage improvements are necessary. Note: this is a very common condition and we do not take pictures of every location, just a couple to help illustrate the extent.
- **Recommendation**: Performing the recommended drainage improvements would help limit the amount of water (and hence this condition), so the recommendation is to make the drainage improvements and monitor.

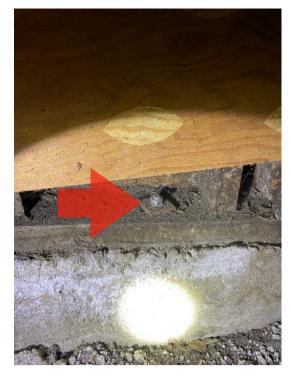
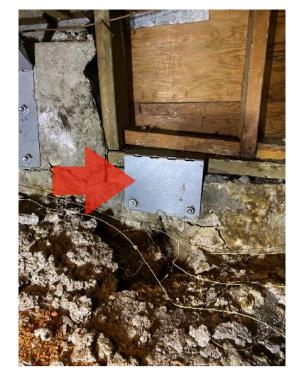
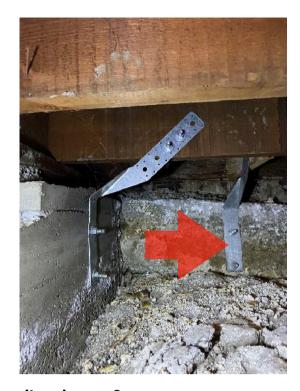
- **Observation Details:** The property is located in a high seismic region. Please refer to Attachment 4 for additional information. The seismic status of the house varies with different foundation connection elements of various vintages present within the crawlspace (Images 1, 2, and 3).

- Additional foundation anchors could be installed between the mud sill and foundation.
  - Metal framing connectors could be installed between the rim joist of the sub-floor and the anchored mud sill.

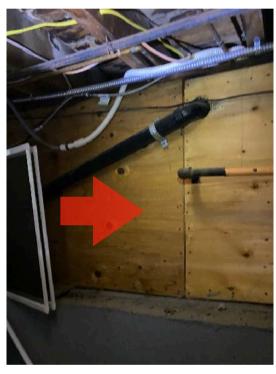
Item Image 4

- Plywood bracing could be installed to the inside face of the wood framed cripple walls where missing (existing shown in Image 4, but missing in some locations as shown in Image 5).

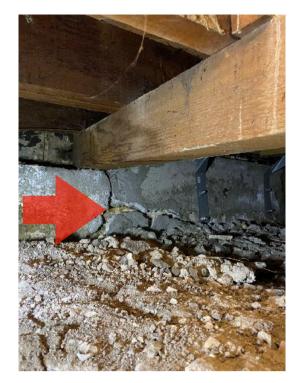
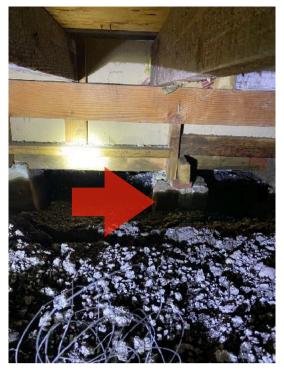
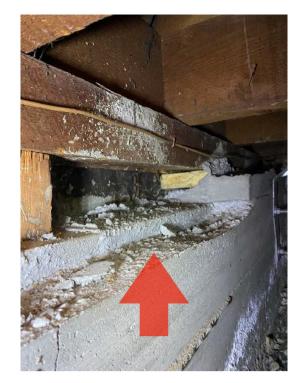
Item Image 1 Item Image 2 Item Image 3

- Observation Details: There is some evidence that the house may have originally been supported by a brick foundation that has been saddle capped or possibly replaced in some locations, but it is not possible to fully determine this based on visual inspection. Cracking of Image 1 does not appear to extend beyond a surgical depth, an existing brick footer was observed through a small opening to the inaccessible portion of the foundation in the rear of the house, and concrete shown in Image 3 appears relatively modern compared to the age of the house. Brick foundations generally do not perform well during seismic events. Given the age of this structure, it has survived major past events but that doesn't necessarily mean it will last through future ones.

- **Recommendation:** Replacement cost would be very high, likely in excess of \$250K depending on the results of a soils report. The county and city records departments should be contacted to locate past permit records to determine what foundation work has been performed as some of the seismic upgrades and concrete shown in Image 3 appear to have been installed within the past few decades. If brick is still present, the key item is awareness and consideration of risk tolerance for future seismic events.

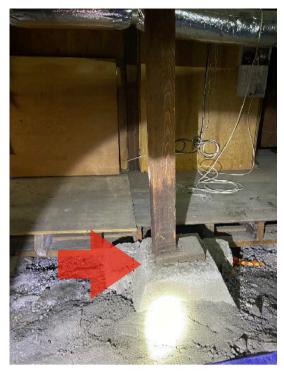
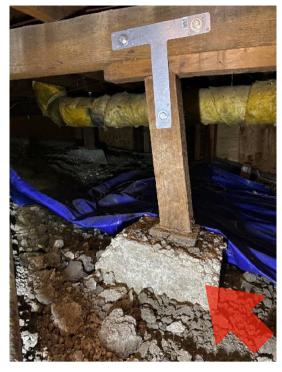
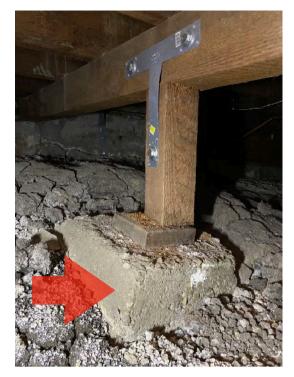
Item Image 1 Item Image 2 Item Image 3

- **Observation Details:** Due to the expansive soils, the individual foundation blocks shown have shifted slightly and the posts are leaning a few degrees. This condition is not abnormal for this age/location.
- Options:
  - Option 1: These could be straightened (Handyman or DIY repair a minimal cost item) and monitored.
  - Option 2: Improve the footers through either new footers that are deeper and wider or supplementing the existing ones by enlarging them around the perimeter and below (relatively shallow underpinning) a budgetary cost range would be \$2K +/- 30% per location.
- Recommendation: The final decision is up to the owner but in general we would recommend Option 2 if the budget exists.

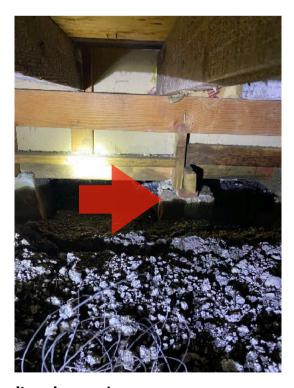
Item Image 1

- **Observation Details:** Individual brick spread footers support the center of the structure at the original floor plan. These footers have been capped with a thin layer of concrete that has deteriorated in several places. The footers show signs of movement and settlement.
- Recommendation: These footers can be replaced with modern reinforced concrete spread footers. The replacement footers need to be designed a licensed professional civil or structural engineer and permitted by the City of Alameda. Budgetary cost range of \$2K +/- 30% per footer.

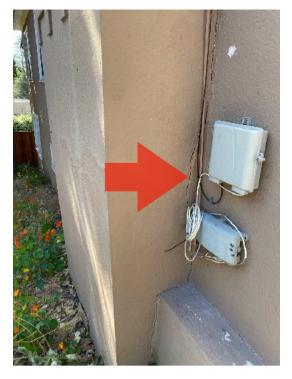
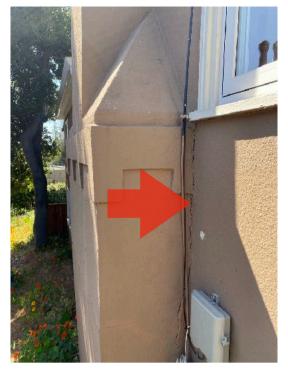
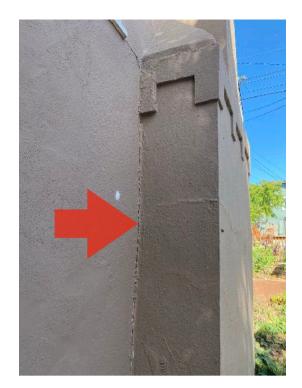
Item Image 1 Item Image 2 Item Image 3

- **Observation Details:** There is a separation crack between the chimney and the wall as shown in the images above. This could be from minor past seismic activity or settling of the foundation for the chimney.
- Options:
  - Option 1: Improve the drainage conditions mentioned previously.
  - Option 2: Patch the crack to allow for a reference point and monitor.
  - Option 3: If the fireplace is not going to be utilized in the future, it would be worth considering reducing the height or fully removing the chimney to lessen the concern from a seismic standpoint.
- **Recommendation**: We would suggest Option 3 in the long term, but Option 2 could be implemented in the near term to monitor the chimney before removing components.

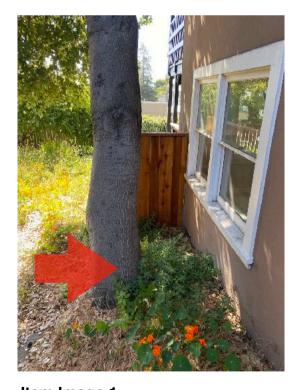
Item Image 1

- **Observation Details:** The tree shown is marginally close to the foundation and should be monitored. No direct issue was noted at the present.
- **Recommendation:** Keep an eye out for any interior cracking or sloping floors in the area of the tree and if desired, consult with an arborist for their recommendation relative to this species of a tree and their experience.

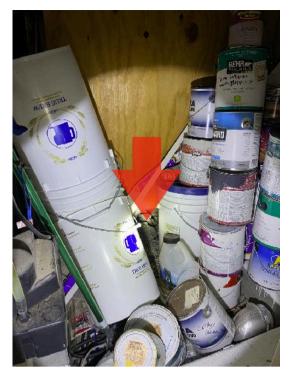
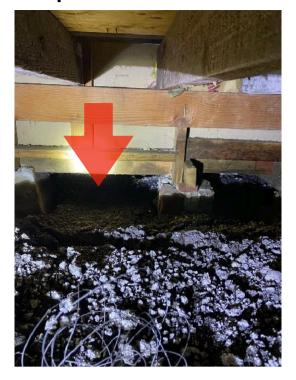
- **Observation Details:** The rear portion of the crawlspace was not accessible due to low clearance. This lack of access limits the inspection and maintenance of the area.
- Recommendation: We would suggest removing obstructions or excavating as necessary (making sure not to negatively impact the foundation) to provide improved access for inspection and improvements.

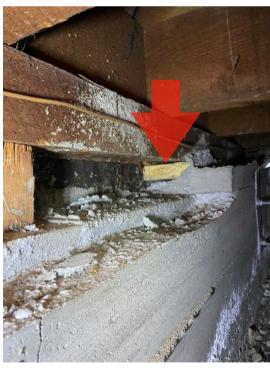
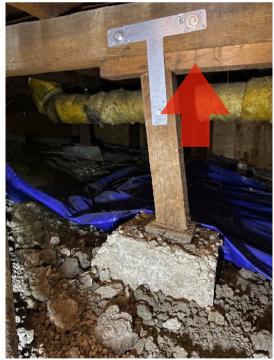
- Observation Details: In addition to the possibility of past foundation capping or replacement, it appears that past efforts to level the house have been made with additional wood blocking (Images 1 and 2).
- Why it's important: If the house has been leveled since the original construction, the results of the floor elevation survey would be indicative of movement that has happened since that leveling as opposed to the date of original construction.
- Severity: Past leveling attempts would suggest that the house has moved more than the current floor elevation survey would suggest.
- **Recommendation**: Based on our experience, future floor elevation surveys should be performed within the next few years to determine the actual rate of movement and guide the decision for potential foundation stabilization.

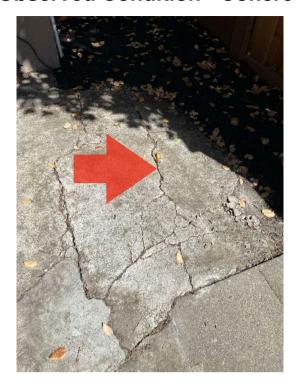
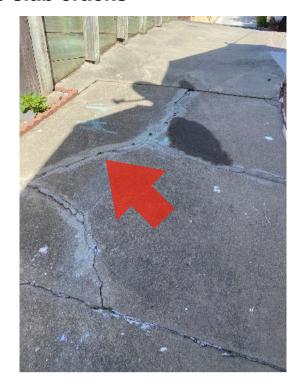
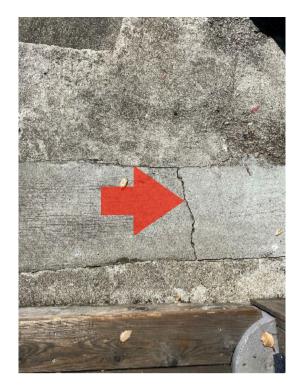
Item Image 1 Item Image 2 Item Image 3

- **Observation Details:** Cracks range from typical minor concrete slab cracking to more significant cracks such as in Image 1 and 2. It is possible that rebar was not used in the slabs and/or the subgrade prep was inadequate. This is damage is not considered a stability concern relative to the house/foundation. (note: we do not take pictures of every location).
- **Recommendation:** More significant cracks could be sealed, or the most affected areas of the slab could be demolished and replaced as desired by the owner (ensure proper subgrade prep & reinforcing steel is used).
