FOUNDATION & DRAINAGE INSPECTION REPORT

524 Avenue, Redwood City

3/6/20

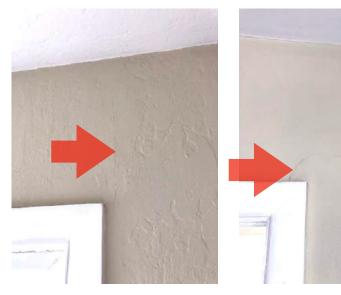
Item Image 3

- There were a few interior indications that could be consistent with minor foundation movement as shown in the pictures above but these were very minor. It has been recently painted so these cracks have formed since then which indicates active movement which will likely continue.

- The movement is likely largely related to expansive soils combined with shallow foundations see Attachment 9 for a further list of potentially contributing factors.

- Recommendation is to ensure surface water is controlled around the property as well as possible as water combined with
 expansive soils can contribute to foundation settlement and patch existing cracks and monitor for future ones and lastly this
 survey can be used as a baseline for future readings to see if there is active movement occurring.

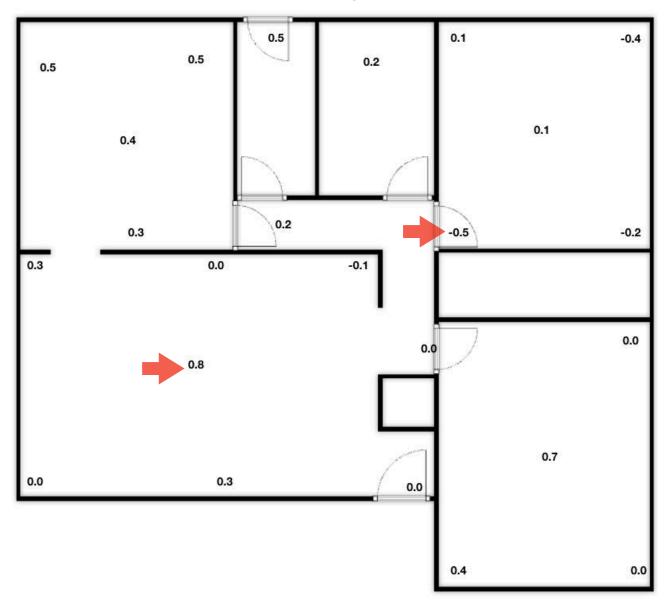
- The interior floors were spot checked for levelness using a Ziplevel manometer. The maximum elevation change was observed to be 1.3" between the red arrows shown.

- There are two tolerance levels for single family homes of which we are aware.
 - The most stringent standard permits a total maximum differential of 1.5 inches over the length of the house, before the house is considered out of level.

- The second standard originates from the Uniform Building Code suggesting a maximum deflection of 1/240. This calculates to a maximum of 1 inch in 20 ft.

- The structure is within these tolerances.
- The only way to fully prevent future movement is underpinning the foundation which taps into more stable soil or rock deep in the earth through push piles (or similar) and brackets which anchor the foundation to the piles effectively supporting it on more stable ground (see illustrations on Attachment 5 and view the Foundation Education link on our website with links to videos on this process). While it is not possible to guarantee that there will be no future movement, based on my experience I would suspect it to be fairly minimal and this underpinning would likely not be required it would be a subjective determination by the homeowner relative to the tolerance for some additional interior cracking and sloping.
