# FOUNDATION & DRAINAGE INSPECTION REPORT

1102 Drive Dr., Cupertino

3/8/20

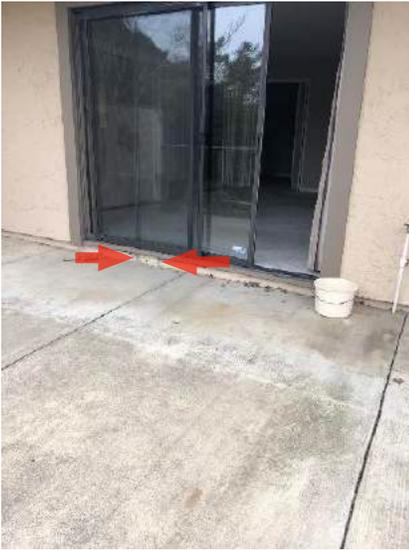
Item Image 1

- It appears there has been some heaving of the slab in this area and is the cause of the cracks shown. The reason it appears that a heaving mechanism is at play is the gap shown in Image 2 and the fact that the sliding glass door now binds up in that area. See on page 5 the floor elevation readings, there was no overall settling issue with the property so this does not appear to be part of a larger issue.

- We investigated around the crack on both sides to remove the loose concrete and see if rebar was near the surface that could have indicated this could have been related to rusting rebar (spalling) that sometimes creates cracking in this manner but I don't believe this the primary mechanism at hand.

- The heaving could be due to expansive soils below (common for the area) and possibly this area not being as well prepped from a subsurface perspective as other areas. Only further investigation will fully show where the crack extends. I walked the area inside the door but could not feel any indication of a crack with my bare feet (which is often times possible if there is a large crack).

- This has likely developed over a lengthy period of time and is not an immediate item but eventually the door will need to come off, the carpet pulled up and the slab then observed for it's condition. I would suspect that the ultimate repair will involved a saw cut of the slab in the area, subsurface prep, doweling into the slab on either side and re-pouring this area. It was noted that the slab has radiant heating to this would need to be taken into consideration during the work so recommend a contractor that is experience with cases such as this.

- **Budgetary cost range of \$5K-10K might be a reasonable range based on what we currently can observe.**

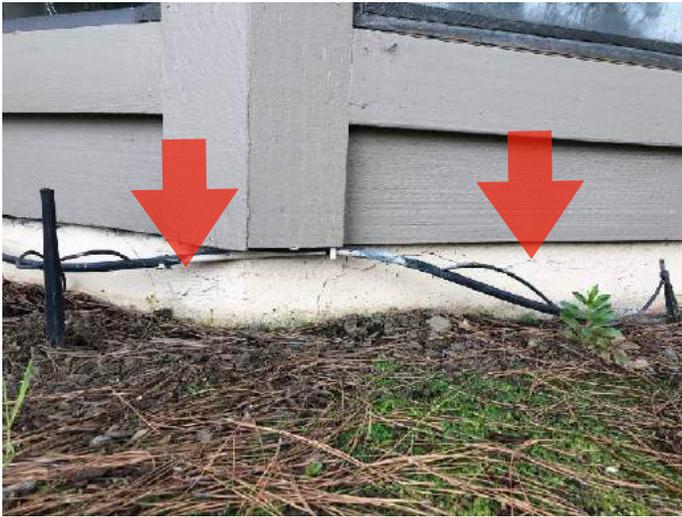
Item Image 1

- The horizontal cracking is likely due to rusting of the rebar (reinforcing bar) within the foundation which is a form of 'spalling'. The rust causes the steel to expand and is a strong enough force to cause the concrete to crack (see image to the right). This is most noticeable where the rebar was placed closer to the forms. There are standard clearances to the side of forms and in some instances this distance is not achieved by the contractors which results in weaker areas. There did not appear to be a larger water related issue that was causing widespread issues with the concrete being saturated and leading to the rusting of the rebar & the spalling.

- There were 2 segments as noted in the pictures, length of the first area (on the left side of the house) was approximately 3 ft and the length of the second area (on the front of the house) was approximately 2 ft.

- Relative to the age, this degree of horizontal cracking is fairly common and would advance slowly so it's not an immediate repair requirement but something to be aware of and plan for.

- The spalling repair procedure for this moderate case is one that many contractors are familiar with. The overview of the procedure is that the cracked areas are chipped away, the rebar then either cleaned or replaced and then special epoxies and mortar then used to seal and repatch the area (see image to the right).

- A budgetary price range for these repairs is typically in the \$500 per linear ft range (+/- 30%).
- **Total budgetary price would therefore be in the range of \$2.5K (+/-30%)**

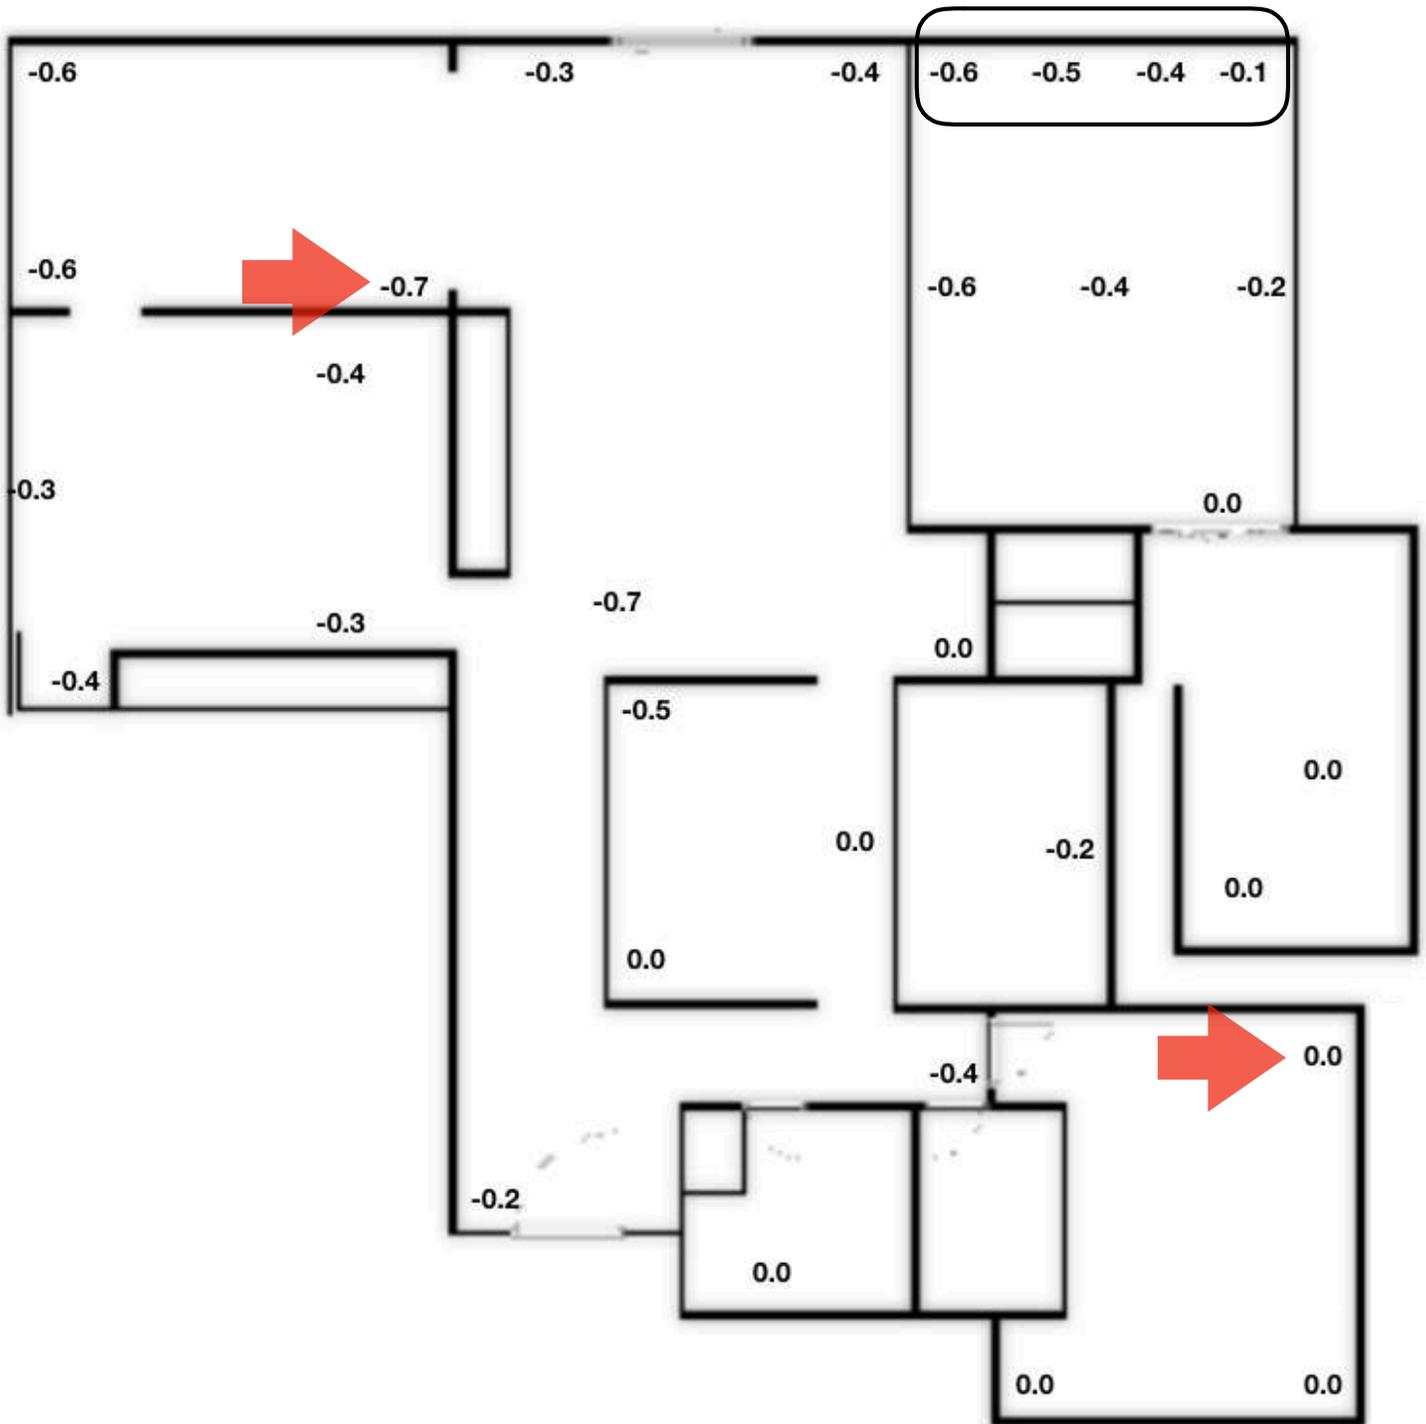
- The interior floors were spot checked for levelness using a Zipline manometer. The maximum elevation change was observed to be 0.7" between the red arrows shown.

- There were no interior indications consistent with foundation movement.
- There are two tolerance levels for single family homes of which we are aware.

- The most stringent standard permits a total maximum differential of 1.5 inches over the length of the house, before the house is considered out of level.

- The second standard originates from the Uniform Building Code suggesting a maximum deflection of 1/240. This calculates to a maximum of 1 inch in 20 ft.

- The structure is within these tolerances. It does not appear that any overall concerning foundation movement is occurring as these readings are within construction tolerances (we discussed the small area of heaving in the previous comment with the readings in this area shown above).

- Recommendation is to use this as a baseline for future readings if there are any future concerns relative to foundation movement.

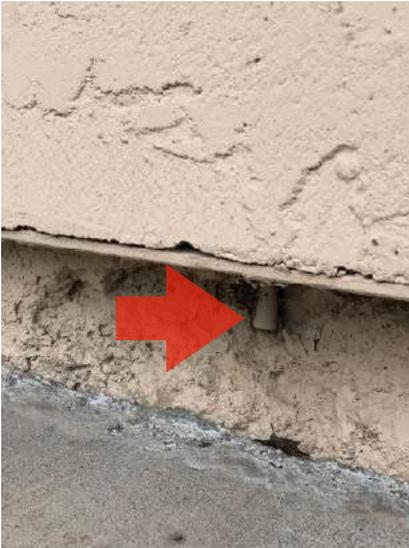
Item Image 1

- The two areas shown appear to be where expansion bolts (likely foundation bolts for securing the mudsill to the slab) were placed too close to the edge of the slab and when they were installed it caused the concrete in the area to pop off. It was not widespread, rest of the exterior edge of the foundation was inspected and no other areas were noted. They are not rusted so it does not appear that rust was the cause of the concrete popping off. Repair would be a relatively minor concrete patch/repair of the area.
- **A budgetary price for the repair of both areas might be in the \$1K +/-30% range.**

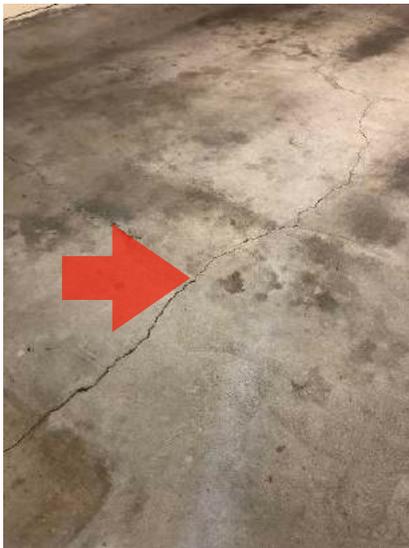
Item Image 1

- Typical minor concrete slab cracking, no expansion/control joints were cut into this large slab which would have then helped direct the cracking in a specific location. Not of a structural concern relative to the house/foundation.
