FOUNDATION & DRAINAGE INSPECTION REPORT

207 Avenue Ave., San Mateo

Report Date: 3/5/20

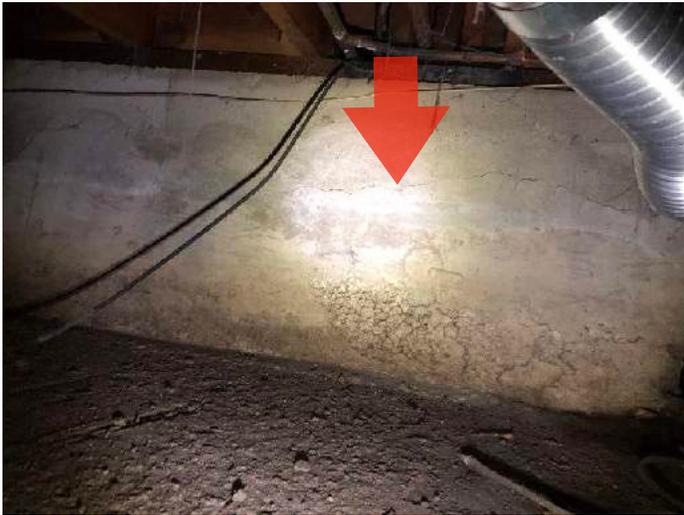
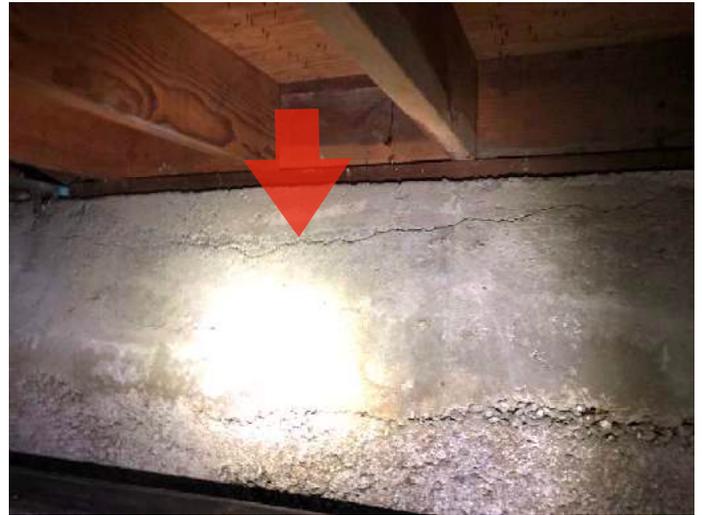
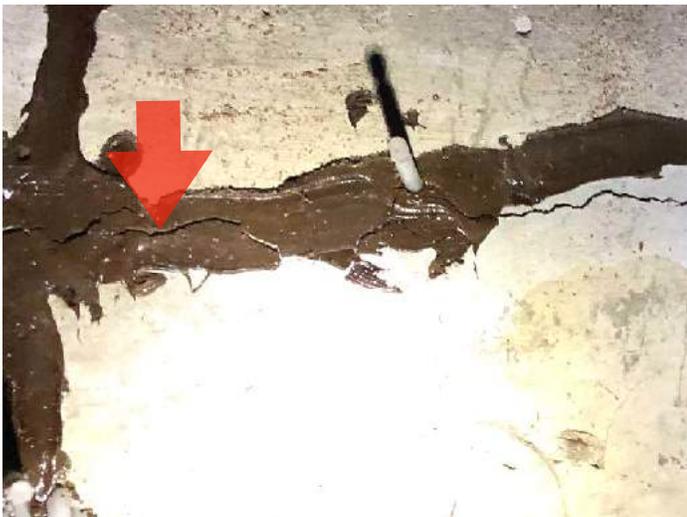
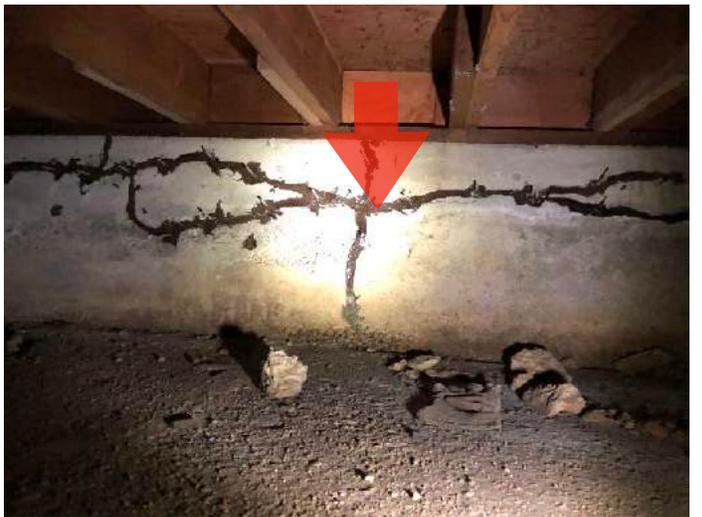
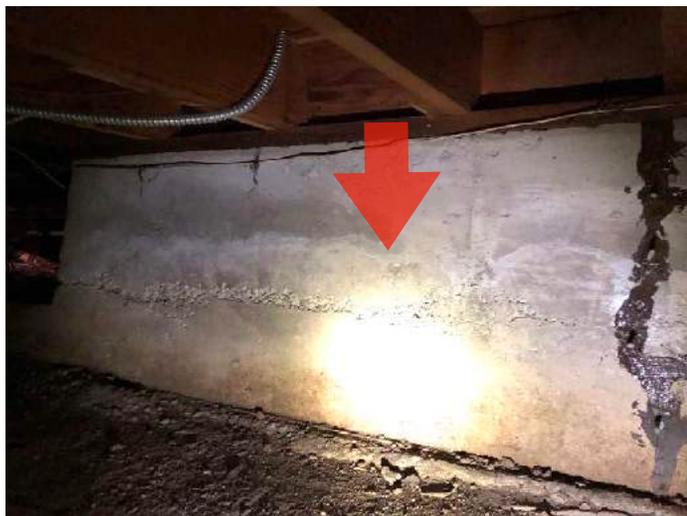
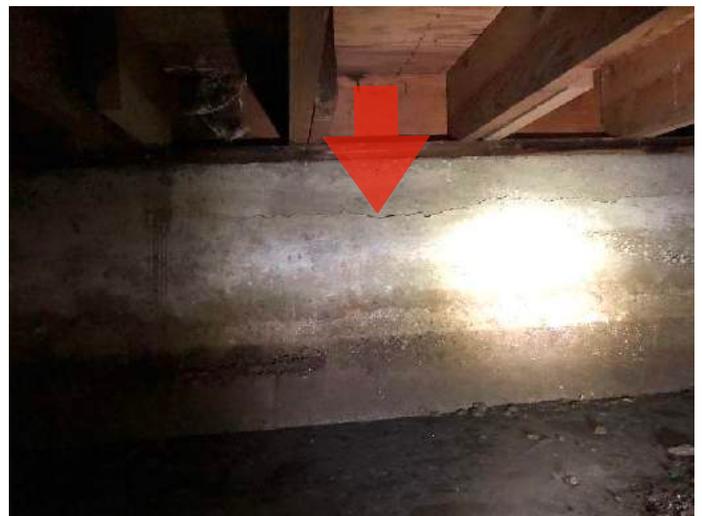
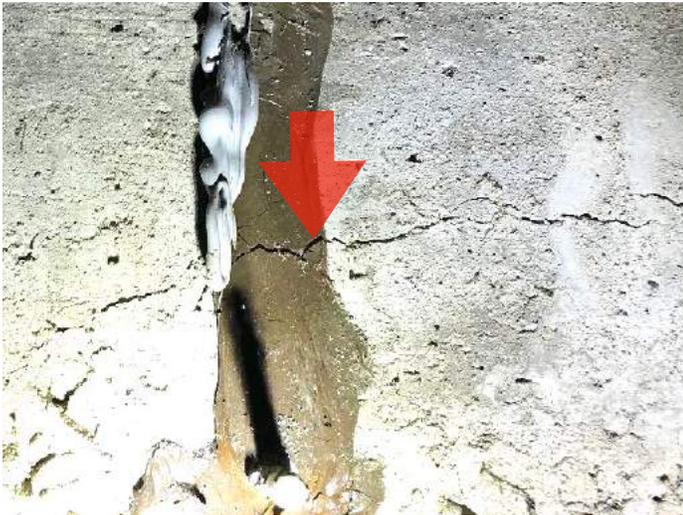
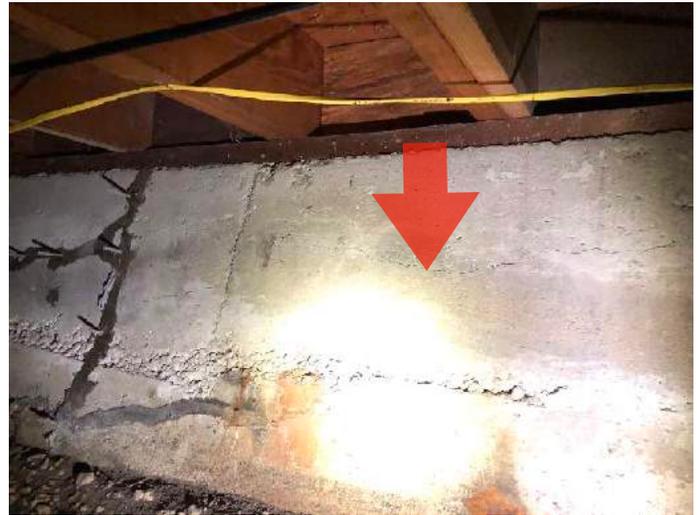
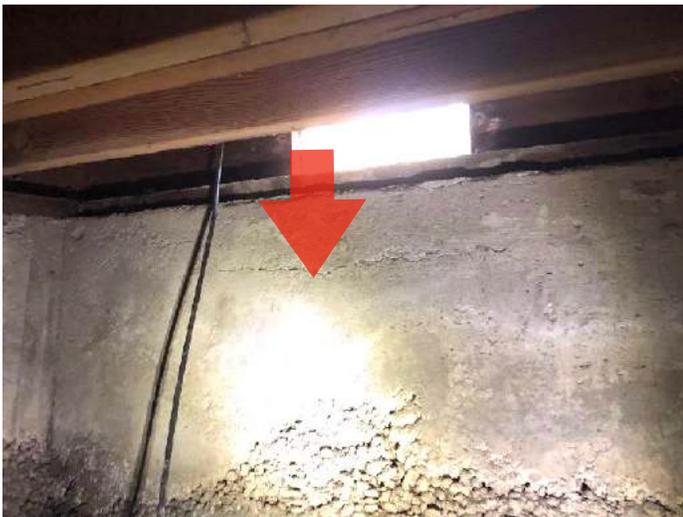
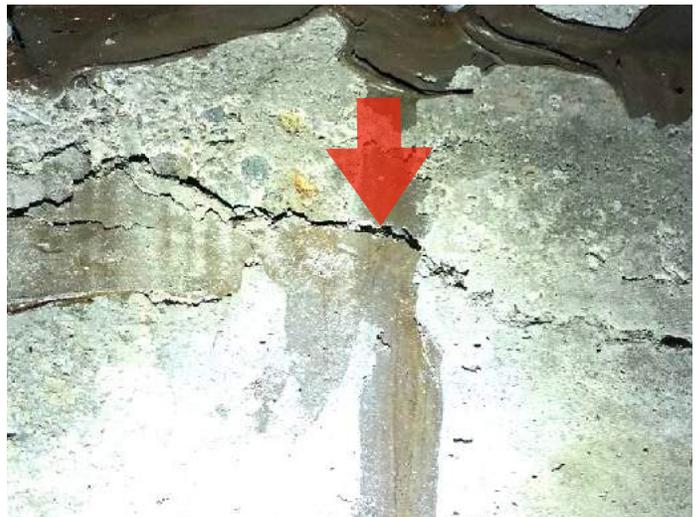
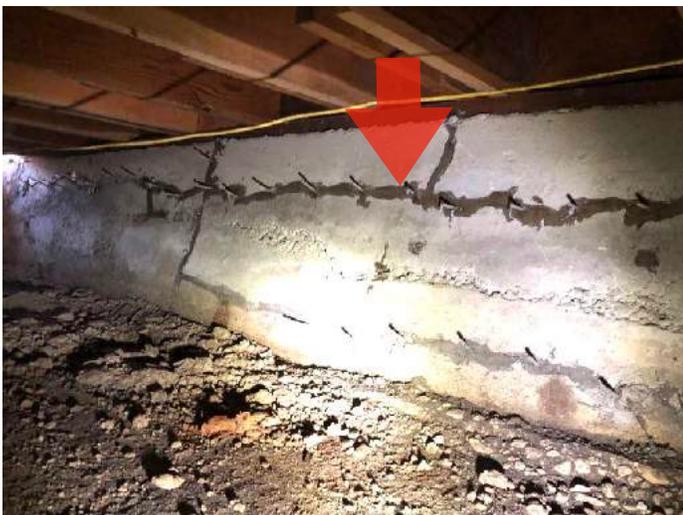
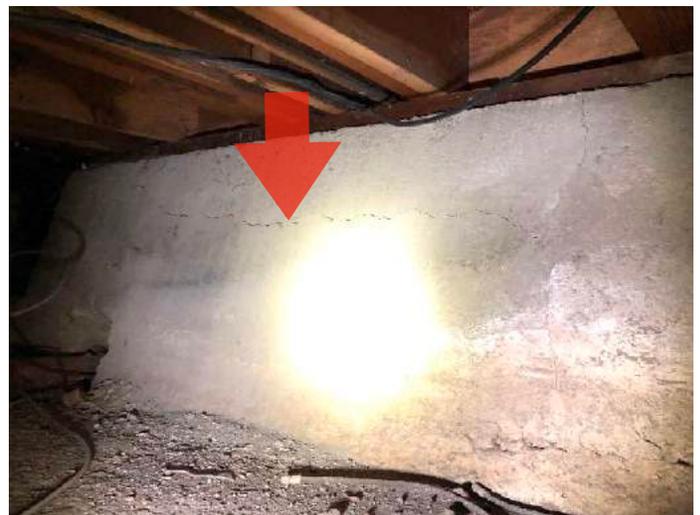
Observed Condition - Horizontal cracking

- The horizontal cracking is due to rusting of the rebar (reinforcing bar) within the foundation which is a form of 'spalling'. The rust causes the steel to expand and is a strong enough force to cause the concrete to crack (see image to the right). This is most noticeable where the rebar was placed closer to the forms but also the other source of the rusting is wicking of water up through the damp soils (common in this area near the Bay) so this is the most likely contributing factor.

- We measured up a total length of 60 ft (+/- 10%) with 20 ft of that matching up to cracking on the opposite side of the stem wall.
- From a budgetary cost standpoint I think that assuming the second approach mentioned above is the one that would be chosen by the contractor and associate engineer.

- Relative to the age, this degree of horizontal cracking is common and would advance slowly so it's not an immediate repair requirement but it's better to address as soon as practical.

- Compared to other homes I've seen in this area, I've seen some cases with less and some with more and would say this would be somewhere in the middle.

- There are various spalling repair procedures that contractors can undertake, the least intrusive process is one that many contractors are familiar with and the overview of the procedure is that the cracked areas are chipped away, the rebar then either cleaned or replaced and then special epoxies and mortar then used to seal and repatch the area (see image to the right). A budgetary price range for this repair process is typically in the \$500/linear ft range (+/- 30%). The more extensive repair generally involves a partial removal and replacement of the foundation. Unless performed in sections, this requires the installation of temporary shoring to safely support the structure while the foundation is removed and replaced or for sections to be performed at a time with pro's and con's for each. Epoxy coated vertically installed steel reinforcing bar dowels are installed into the remaining bottom portion of the existing foundation, horizontally installed epoxy coated steel reinforcing bars are installed to the vertically installed steel dowels. Concrete forms are installed. The new upper portion of the foundation is poured with concrete treated with Xypex (an additive that helps the new concrete become more water resistant) which helps protect the new epoxy coated steel and helps to prevent spalling concrete. A budgetary price range for this repair process is typically in the \$1,000/linear ft range (+/- 30%). In general, it is the second approach that is mentioned that is the preferred repair method in these areas where the source of the rusting is the wicking of the water up from below. The attempted epoxy repair was not effective as you can see it's cracked since, from my understanding this type of repair is no longer approved by the building department. The repairs that have been done may have held the areas together better for a while but eventually it will fully crack through.

- **In conclusion, I would put the budgetary range a good range would be 40 x \$1,000 per linear ft = \$40K (+/- 30%).**

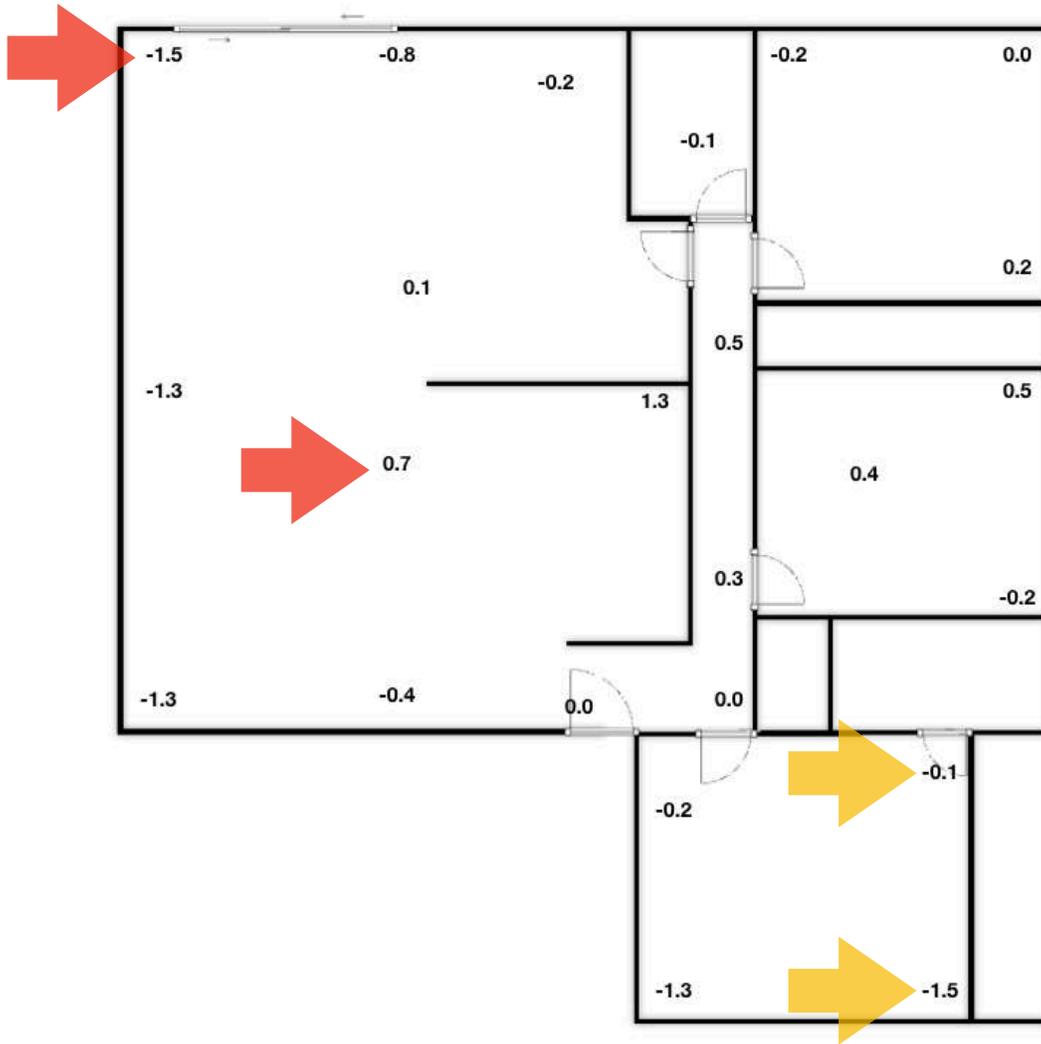
Observed Condition - Floor elevation results & signs of foundation movement

- The interior floors were spot checked for levelness using a Zipline manometer. The maximum elevation change was observed to be 2.2" between the red arrows shown and then for the added lower slab, a total of 1.4 inches as shown between the yellow arrows (note: the slab may have been poured with an intentional slope if it were once used as an outdoor patio).

- There were no interior indications of movement.
- There are two tolerance levels for single family homes of which we are aware.
 - The most stringent standard permits a total maximum differential of 1.5 inches over the length of the house, before the house is considered out of level.

- The second standard originates from the Uniform Building Code suggesting a maximum deflection of 1/240. This calculates to a maximum of 1 inch in 20 ft.

- The structure is outside of the first of these tolerances but within the second, this is not uncommon for this age and in this area and overall, is less movement than I typically see for houses in this area.

- The last tolerance is a more subjective one in that people will not notice the overall degree of movement overall as much as the movement in any one particular room. Generally, for rooms that have less than a 1.5 inch amount of difference it's not to the point of detectability and/or not affecting the livability of the room. In this case I did not get the sense that the movement affected the livability of the house since its spread out evenly over multiple rooms/spaces.

- In the Bayside locations of San Mateo, Foster City and Redwood Shores, there has been differential settlement of the underlying soils over the extended time since original development. This commonly will cause deformation and sloping of foundations. The precise cause of the differential movement is beyond the scope of this report but would generally be the result of a shallow foundation in conjunction with the underlying soft Bay Mud (see Attachment 9 for further possible contributing factors and explanations). A licensed Geotechnical Engineer would be better able to address this issue based on subsurface analysis (soils report). It is impossible to predict the future performance, or ongoing rate of movement without the benefit of subsurface information and past history of the property (past floor elevations survey's to compare to and time between interior painting and the formation of cracks as a few examples). In general though, for movement related to consolidation, the movement is early in the life and then settles out. Based on this I don't think this is a case where stabilization would generally be undertaken.

- This survey can be used as a baseline for future monitoring.

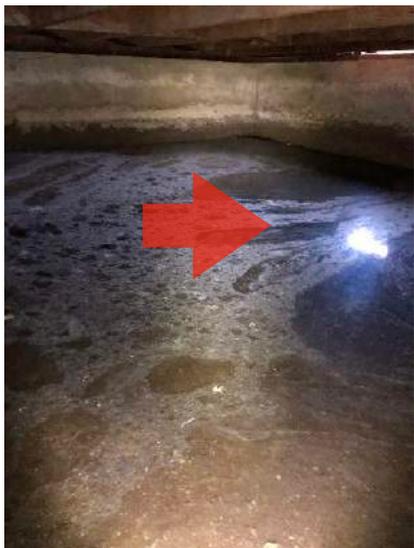
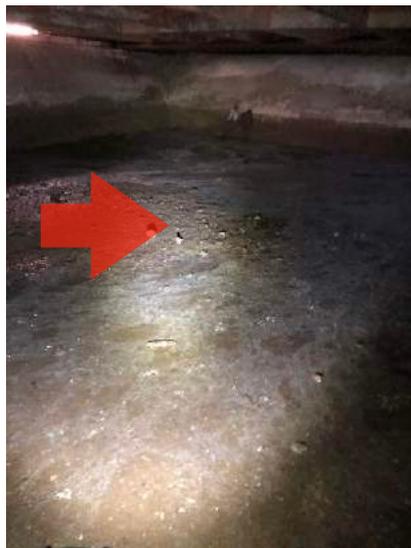
Observed Condition - Standing water in the crawlspace

- The front crawlspace chamber had approximately 1-4" of standing water at the entrance. A sump pump should be installed, depending on the slope of the crawlspace slab it may require 2 in this area. The other chambers were just damp but there is the potential that under some conditions that they have standing water so these should be monitored.
- The cost range per installed pump may be in the \$2K range (+/-30%), assuming it would just be 2 needed then it would be a total of \$4K (+/- 30%) minimum (the back chambers still need to be monitored).

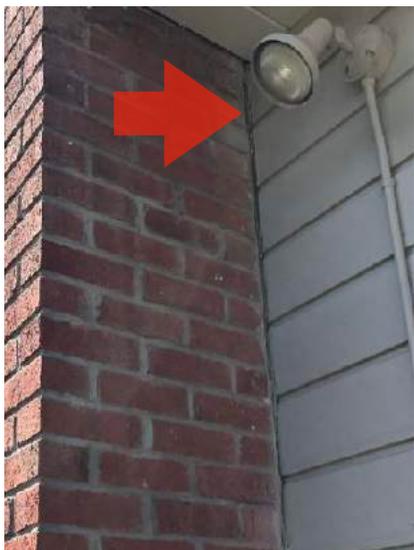
Item Image 1

Observed Condition - Signs of chimney movement

- There is a small separation crack between the chimney and the wall. This is fairly minor and likely from past seismic activity or very slight settlement but nothing of concern. Recommendation would be to patch the area with an exterior caulking and monitor.

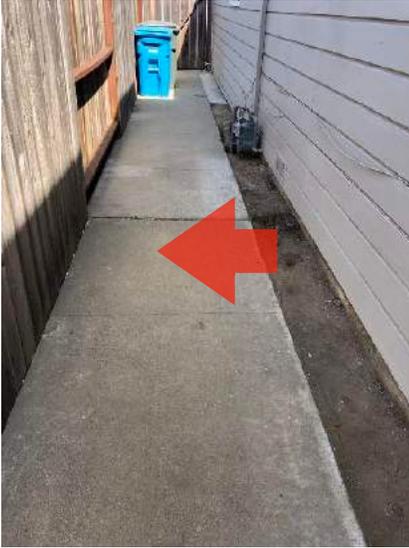
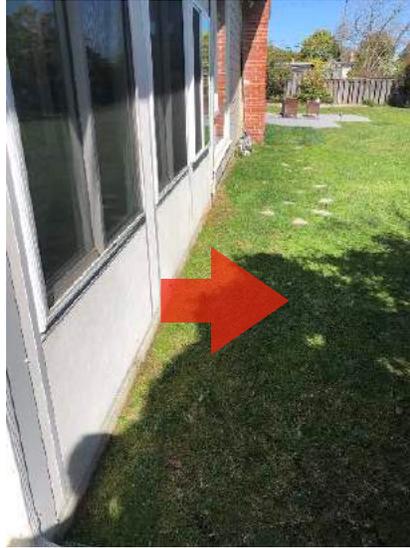
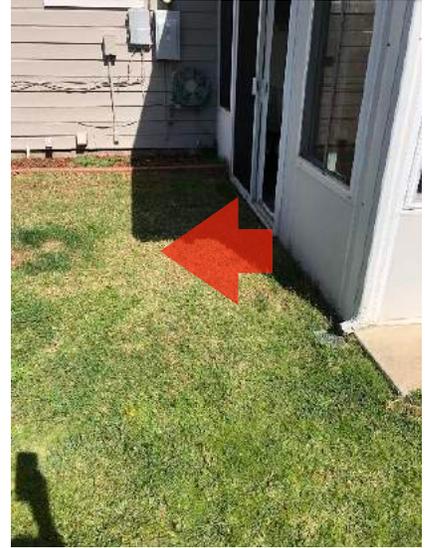
Observed Condition - Drainage improvements - exterior grade/slope

- It is recommended to ensure adequate slope away from the house in all areas & recommend hardscape as the best option (see attachment 3 for illustrations relative to the grade depending on whether or not it's hardscape or porous (i.e. dirt or grass). On the right side (Image 1), the hardscape slopes away from about half of the length and then towards the front of the house it slopes back towards the house.
- For a house of this age with the horizontal cracking and water in the crawlspace, it would also be recommend to look into having subsurface drainage (french drains) installed in the future to help minimize the water near the foundation. However, there would likely still be water coming up from the center given the high water table in these areas so the french drain may still not fully address the water issue.

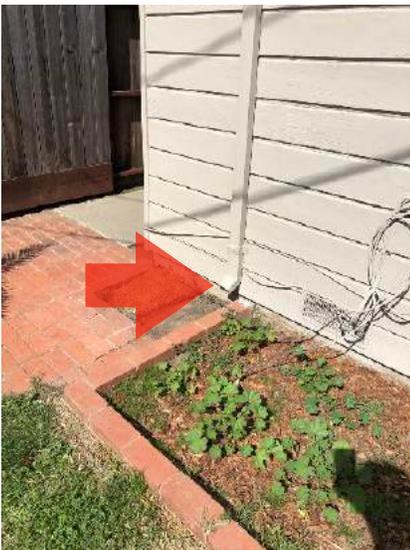
Item Image 1

Observed Condition - Drainage improvements - downspouts

- It is recommended to ensure all downspouts have extenders added to discharge water at least 5' from the house or discharge onto hardscape that then flows away from the foundation at least 5'

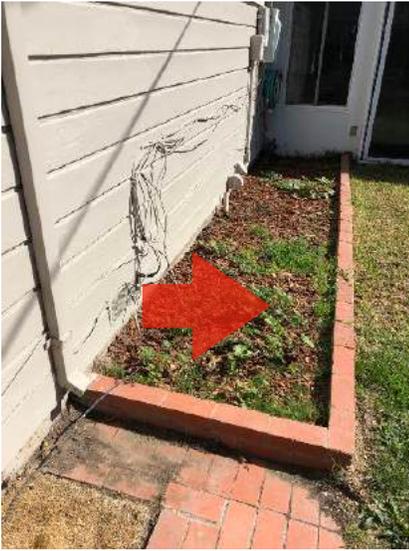
Item Image 1

Observed Condition - Drainage improvements - planters near foundation

- It is best to avoid planters near the structure as they tend to trap water next to the foundation and it is recommended that there be positive sloping of the grade away from the foundation.

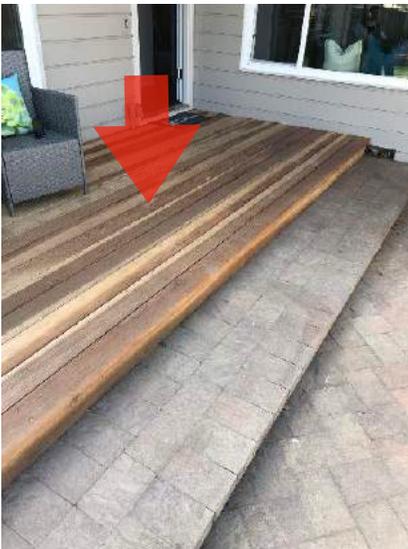
Item Image 1

Observed Condition - Drainage improvements - possible lack of positive drainage under deck

- We can not see below the decking but it's possible there isn't adequate drainage away from the foundation in this area but should be added when the opportunity presents itself - alternatively, adding a roof over this area would help with this if the roof water is then directed away from the foundation. Since the crawlspace was dry (in the winter) and the foundation performance has been satisfactory over the life of the structure, these would not be improvements that require immediate attention.

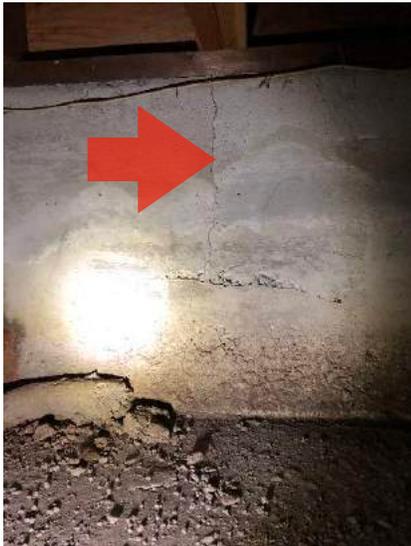
Item Image 1

Observed Condition - Foundation crack

- There was 1 small vertical crack 1/8 in or less. These generally occur from past either seismic activity or a combination of shallow foundation embedment depth and expansive soils which will swell when wet and contract when dry (see attachment 2).
- For cracks this small, they are generally marked and monitored.

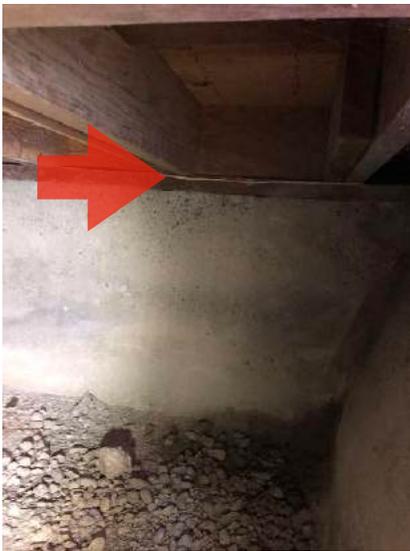
Item Image 1

Observed Condition - Seismic risk mitigation notes

- **Cost wise, considered an 'upgrade' relative to a real estate transaction - currently consistent with age**

- Please refer to Attachment 4 for additional information and illustrations related to the comments below.
- As desired, more comprehensive seismic upgrades could easily be installed to the sub-structure area. Additional foundation anchors could be installed between the mudsill and foundation. Metal framing connectors could be installed between the rim joist of the sub-floor and the anchored mudsill. These recommendations are detailed in the pre-engineered plan set for single family homes prepared and provided by the Association of Bay Area Governments (ABAG).

- These recommendations are also detailed in the Applied Technology Council (ATC) report "Seismic Rehabilitation Guidelines for Detached, Single-Family, Wood-Framed Dwellings" (document ATC-50-1) and have been recommended by the Federal Emergency Management Agency (FEMA) a division of the U.S Department of Homeland Security. Additional information can be found at the following: Earthquake Brace & Bolt (California Residential Mitigation Program) www.earthquakebracebolt.com, California Earthquake Authority www.earthquakeauthority.com & Quake Prepare www.quakeprepare.com.

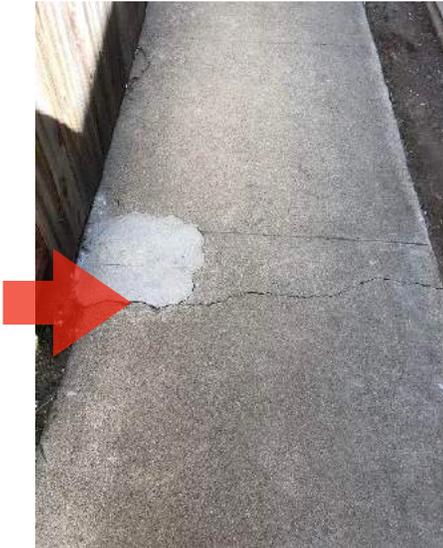
Item Image 1

Observed Condition - Concrete slab cracks

- Typical minor concrete slab cracking, not of a structural concern relative to the house/foundation. It is possible that rebar was not used in the slabs and/or the subsurface prep wasn't adequate. The areas could be patched to extend the life or replaced as desired
